(NASA-CR-183585) SPACE STATION PROTECTIVE
COATING DEVELOPMENT Final Report (Boeing
Aerospace Co.) 304 p CSCL 22B

SPACE STATION PROTECTIVE COATING DEVELOPMENT

Final Report

**Contract NAS8-36586
January 1989**

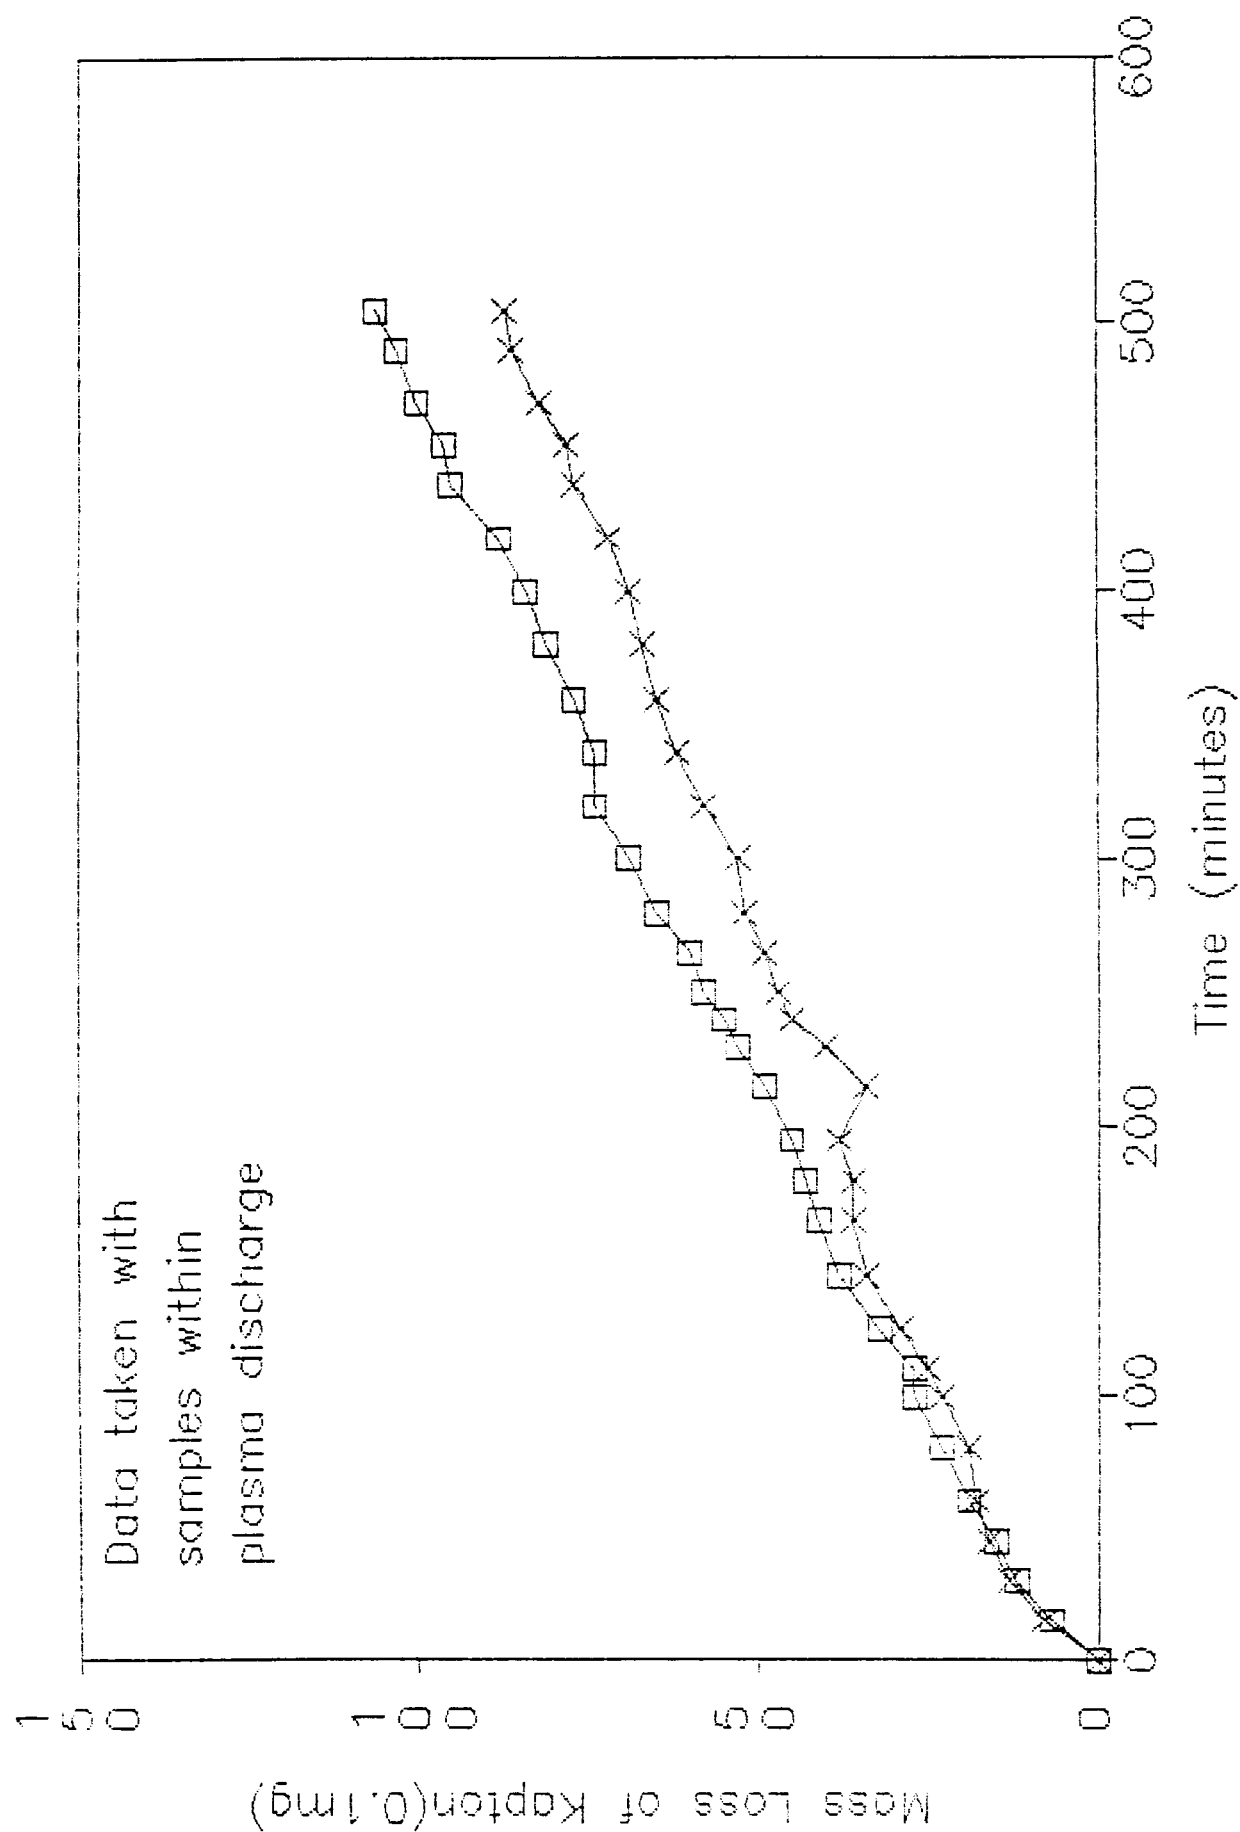
Figure 149: Mass Loss of Kapton Exposed to an Atomic Oxygen Plasma.
Specimens Were 1.5" in Diameter.

Tetrafluoroethylene (TFE) shows very little mass loss when exposed to only neutral atomic oxygen. However, when placed in a dilute plasma environment which contains excited state species, UV, and ions as well as atomic oxygen, the TFE mass loss rate is greater than for Kapton under identical conditions. This data is shown in figures 149 to 151; data on FEP is included for comparison. In each figure the curve showing greater mass loss is for a sample placed at the center of the plasmod. The lower curve in each figure is for a sample near one end of the plasmod.

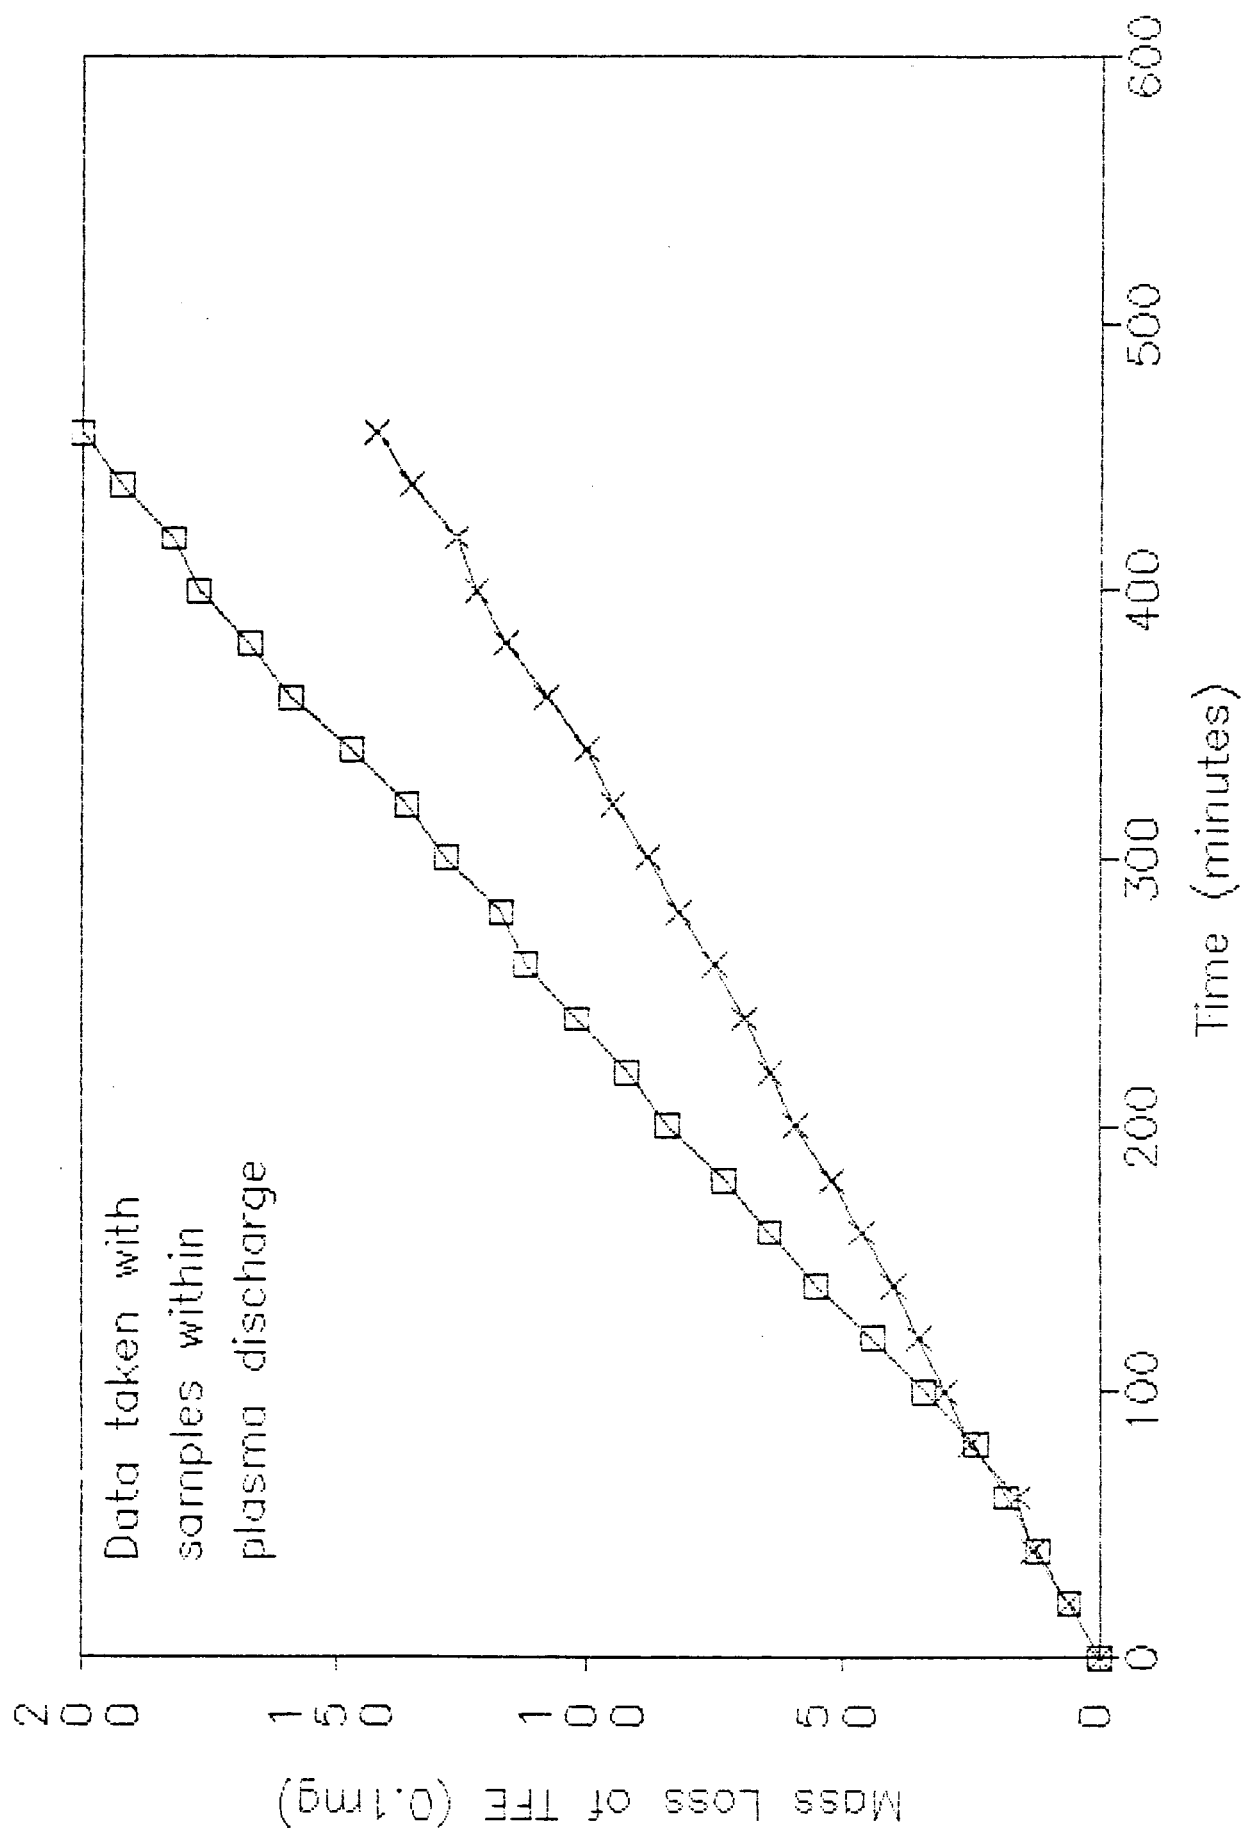
Figure 150: Mass Loss of TFE Exposed to an Atomic Oxygen Plasma. Specimens Were 1.5" in Diameter.

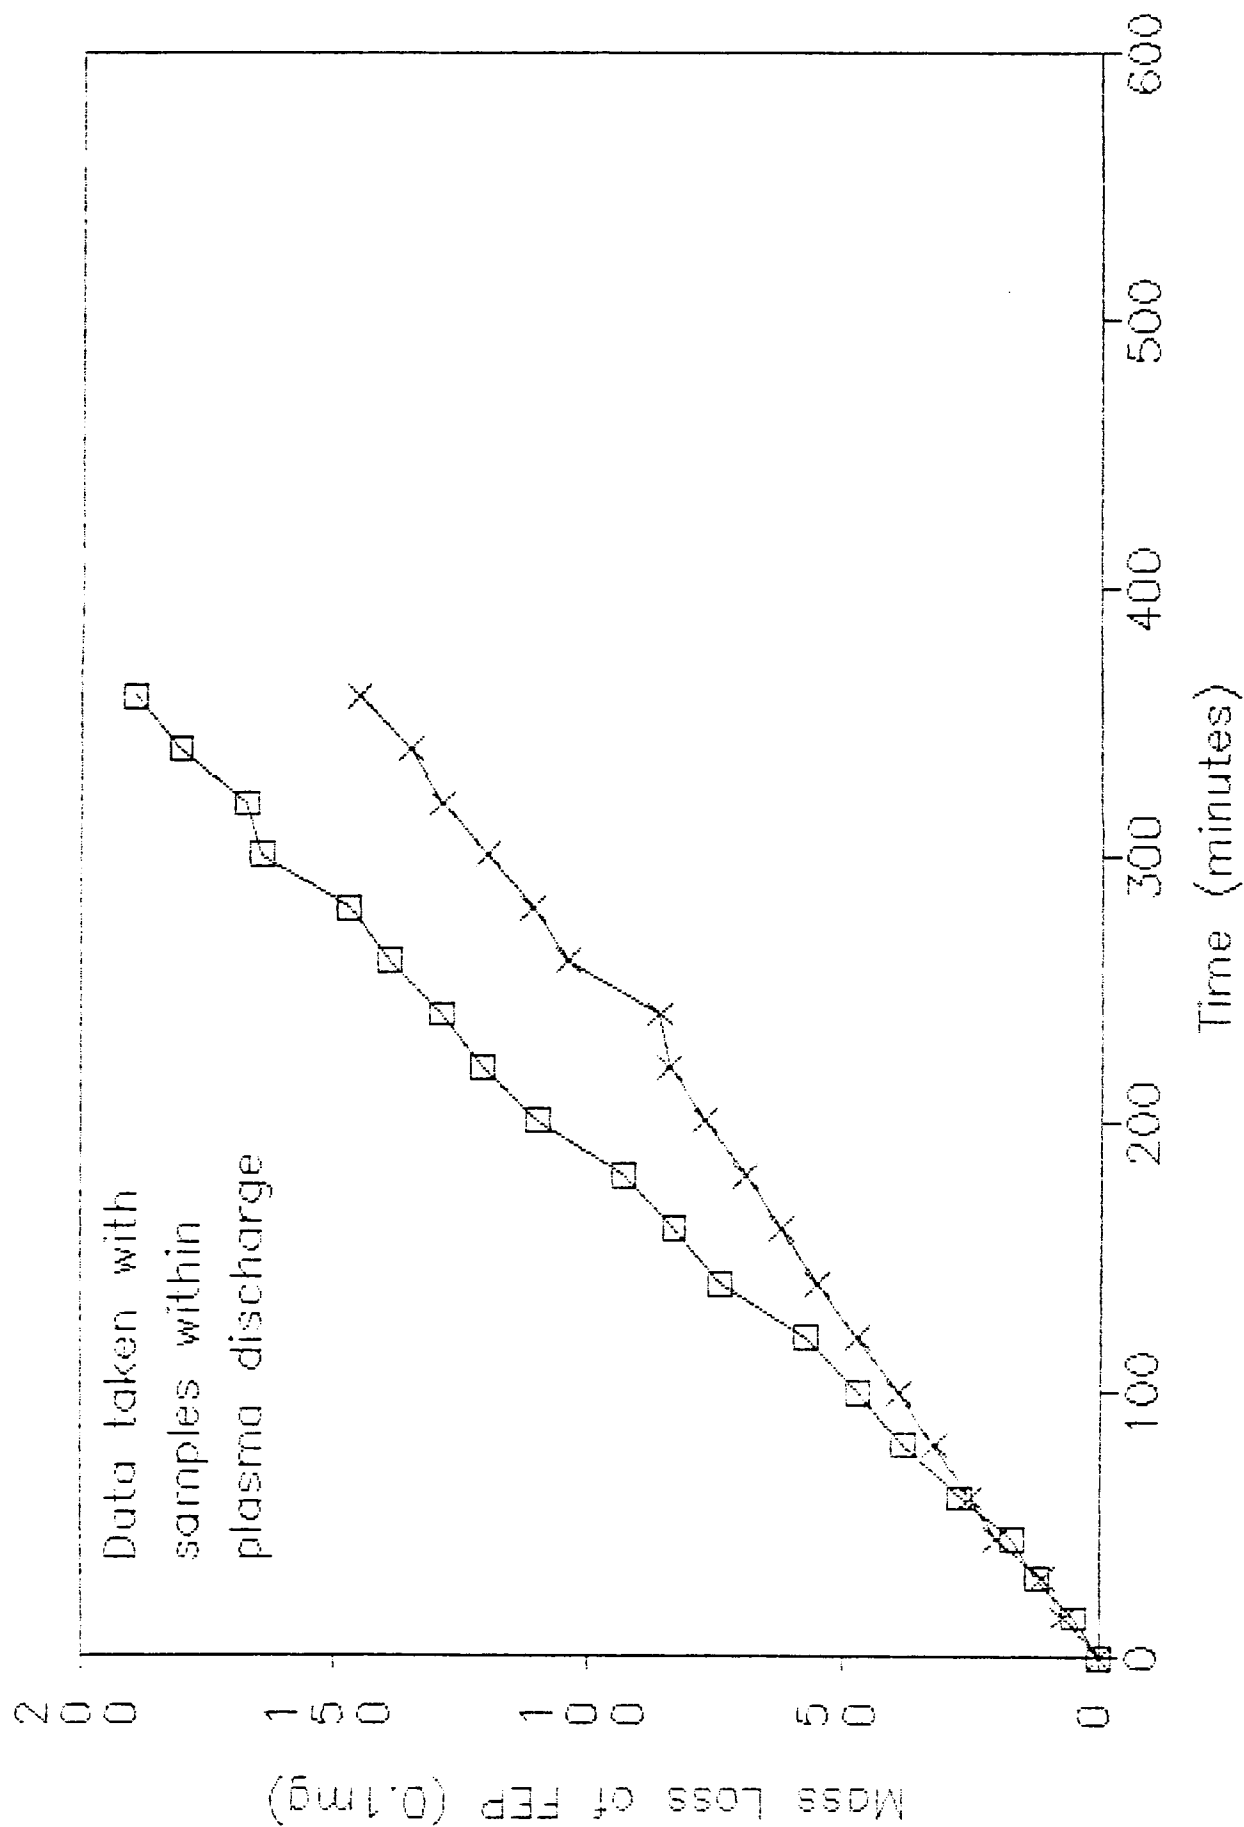
Figure 151: Mass Loss of FEP Exposed to an Atomic Oxygen Plasma. Specimens Were 1.5" in Diameter.
